Debris/Ice/TPS Assessment And Photographic Analysis For Shuttle Mission STS-39

Gregory N. Katnik
NASA/Kennedy Space Center

June 1991

DEBRIS/ICE/TPS ASSESSMENT
AND
PHOTOGRAPHIC ANALYSIS
OF
SHUTTLE MISSION STS-39

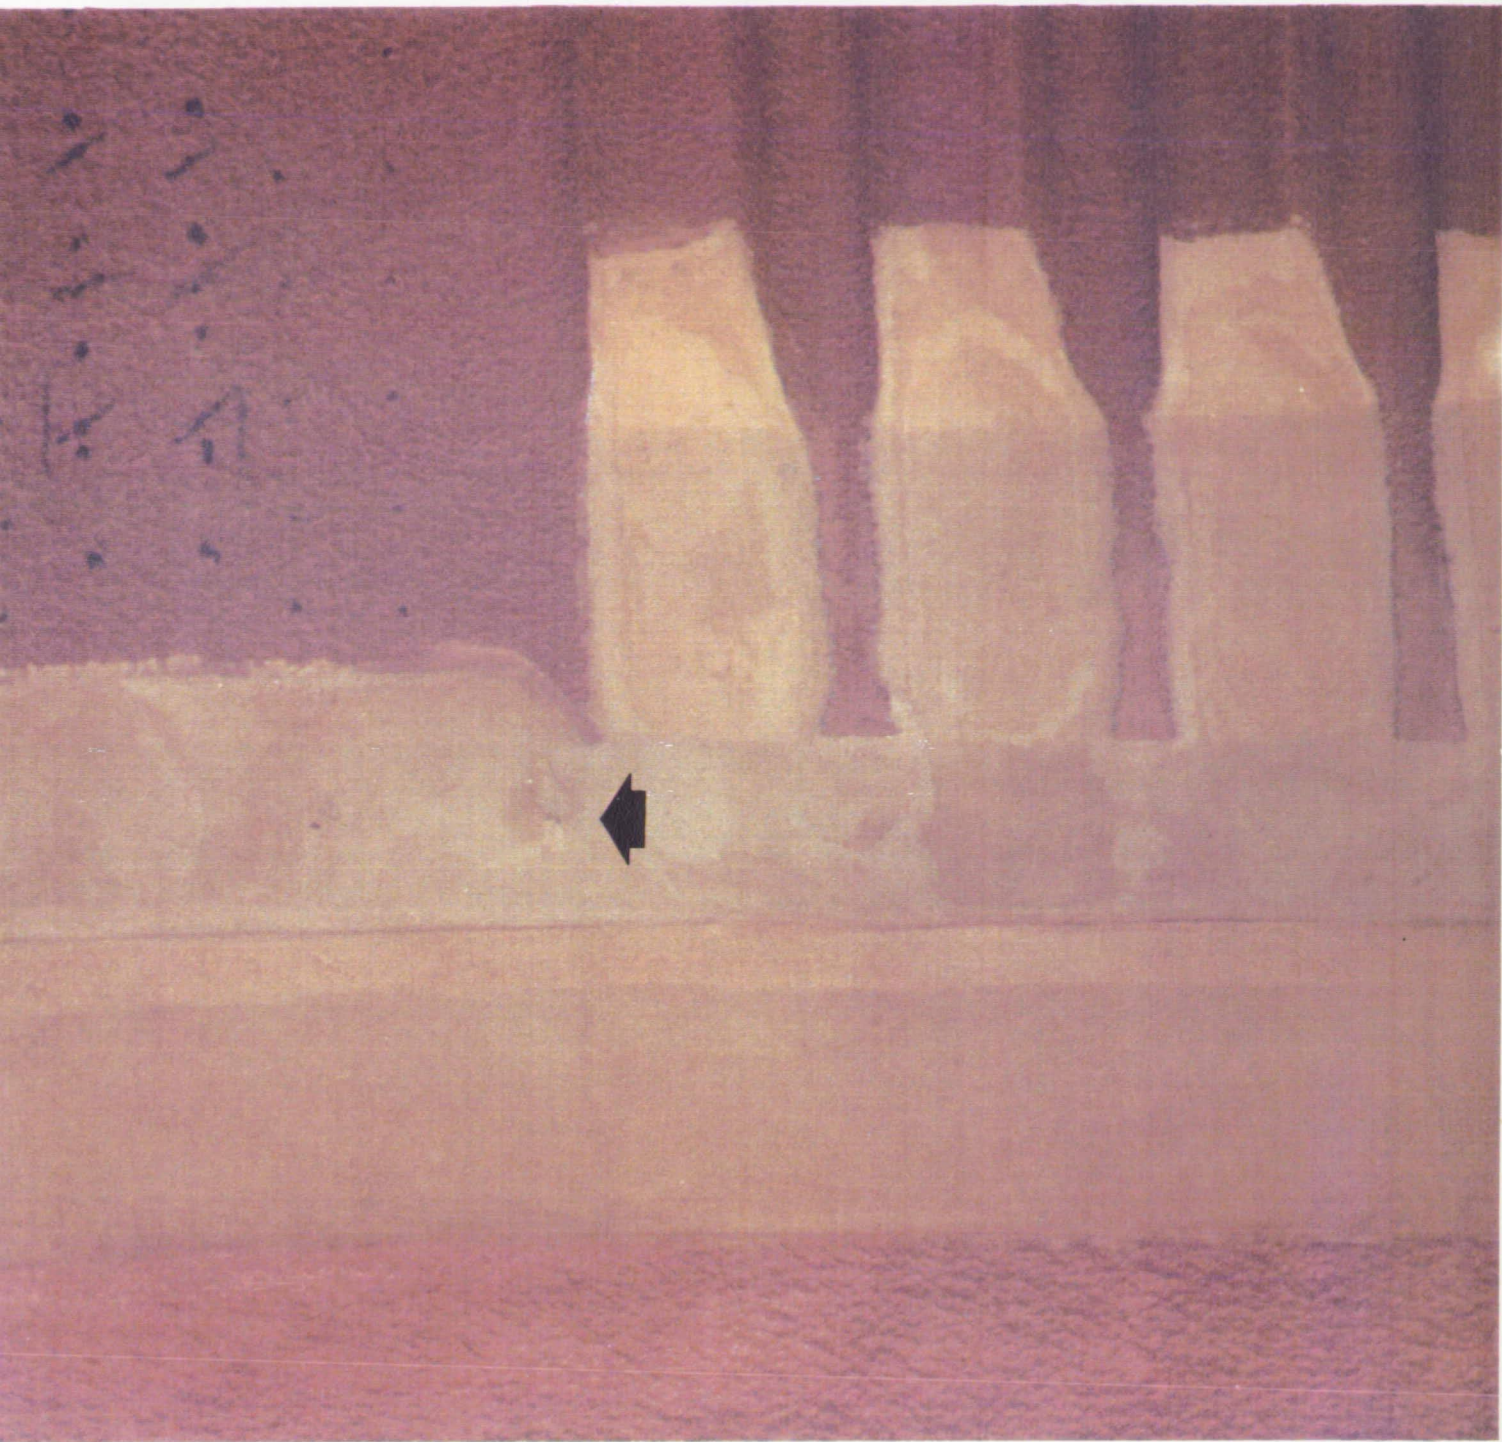
Small void on the LH2 tank-to-intertank flange closeout marked the location where a 1-inch diameter ice/frost ball had formed. The small size of the TPS defect did not require repair prior to the next cryoload.

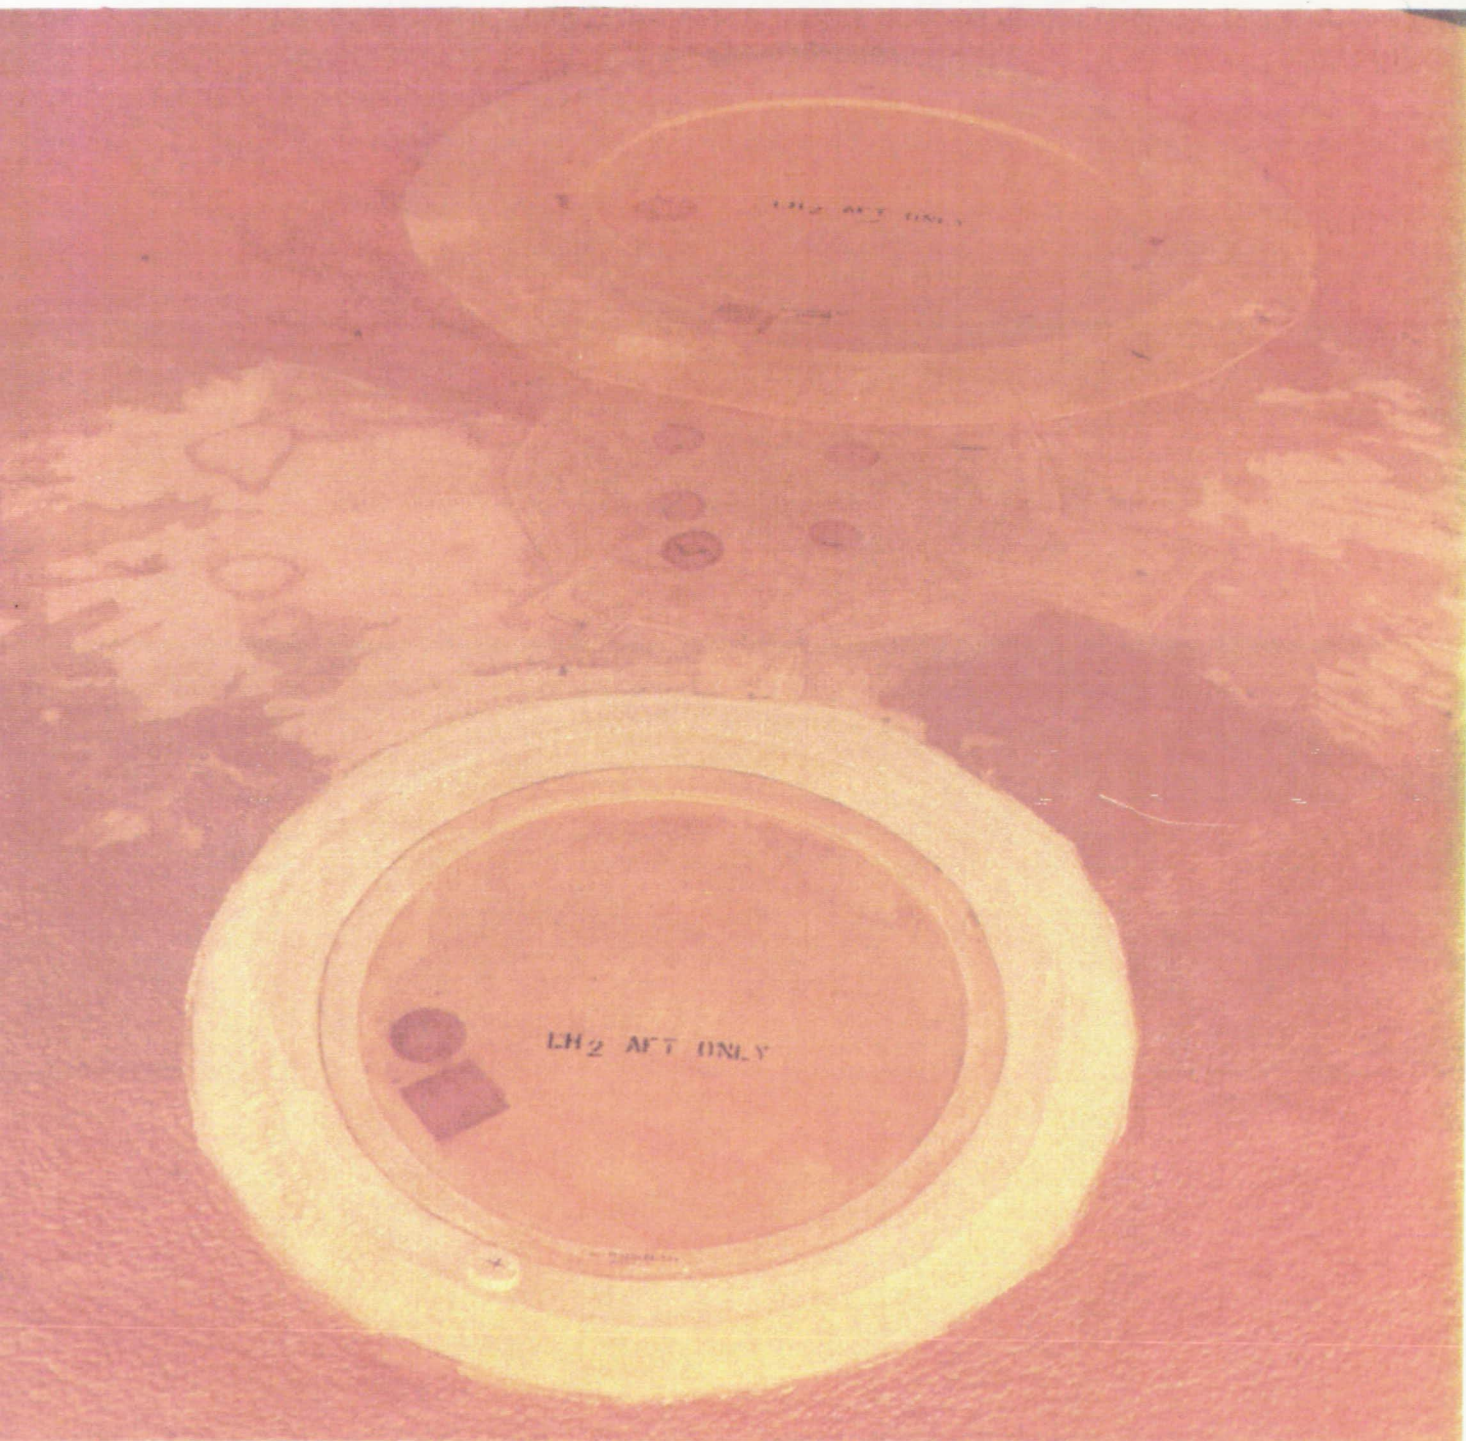
Vapors vented from the LH2 tank aft dome +Z manhole cover TPS closeout (+Y side) at the outer closeout perimeter during cryoload and drain. No TPS anomaly was visible.

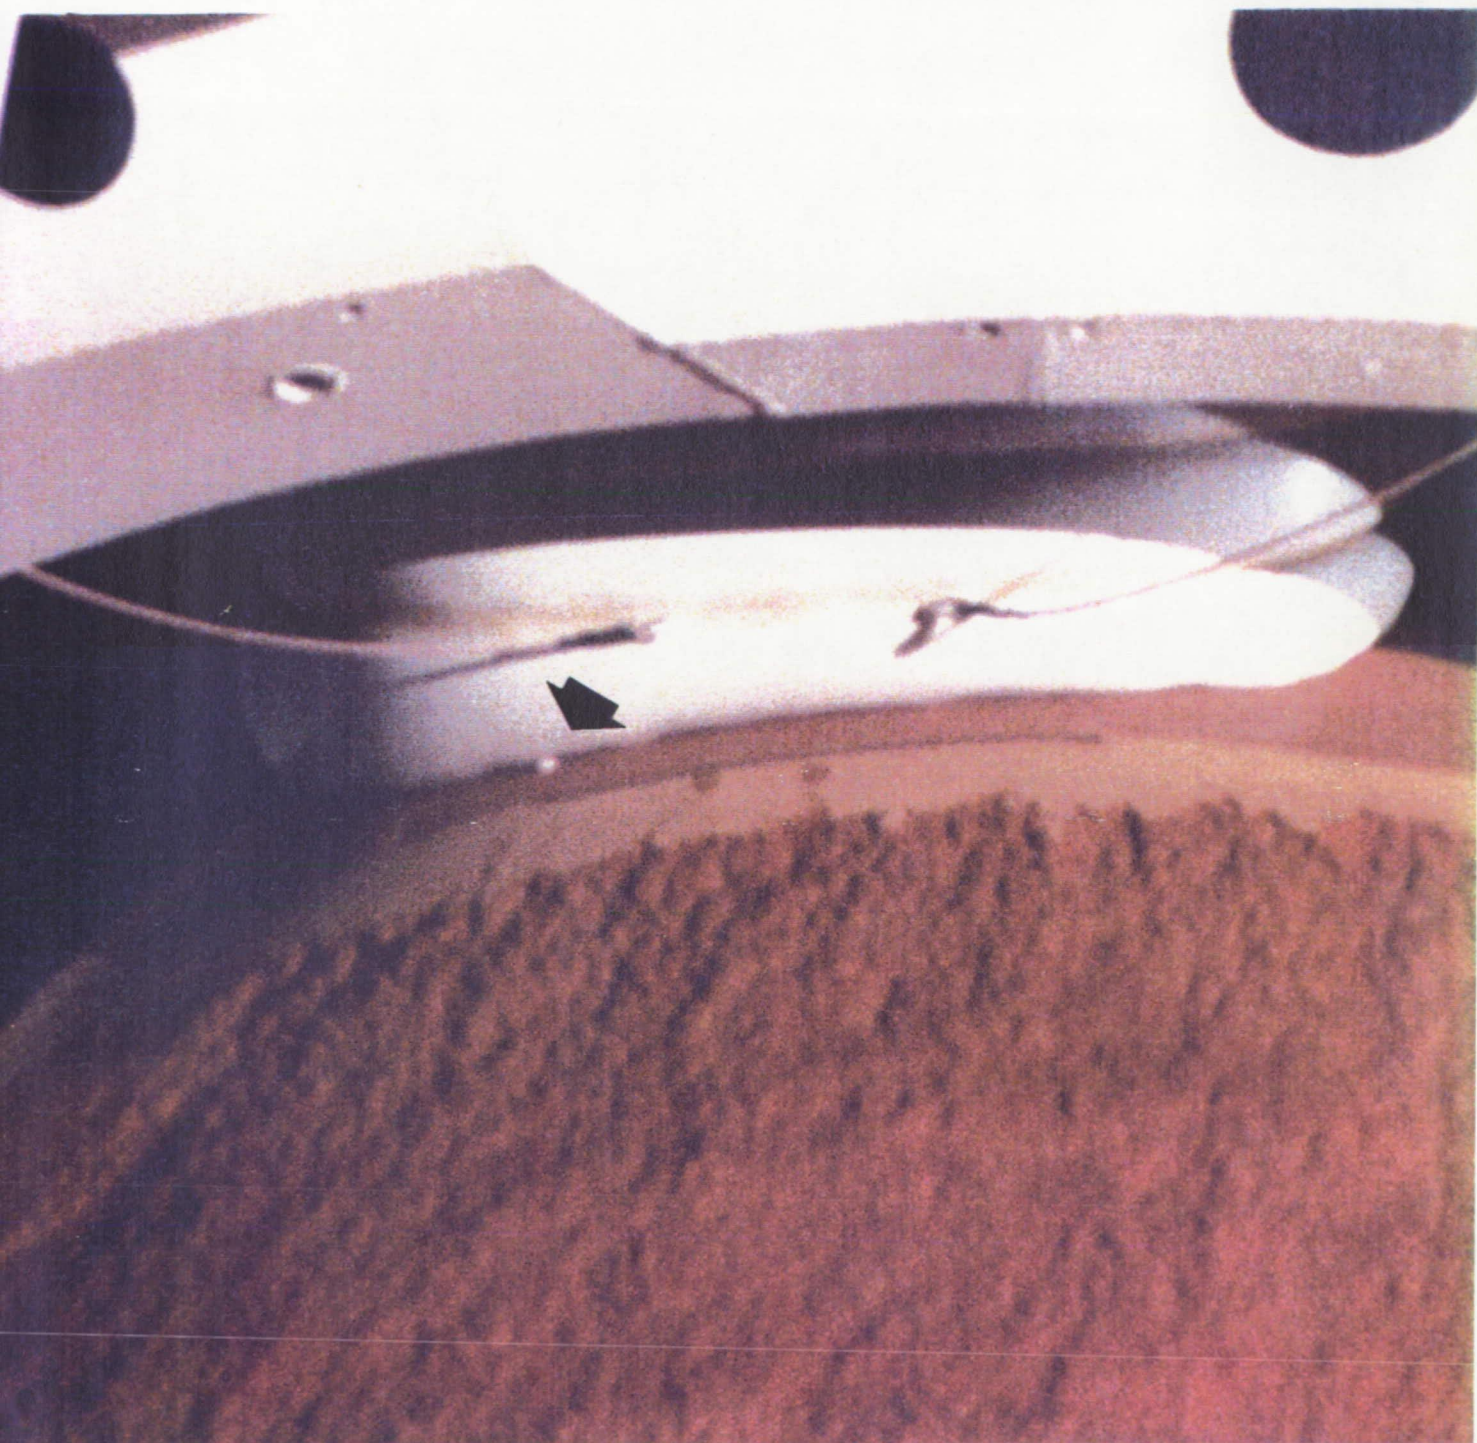
Small white debris particle or ice ball 1/2-inch in diameter was visible between the southwest (-Y) GOX seal and the ET TPS/footprint. GOX vent hood retraction prior to launch revealed no TPS damage or ice/frost accumulation.

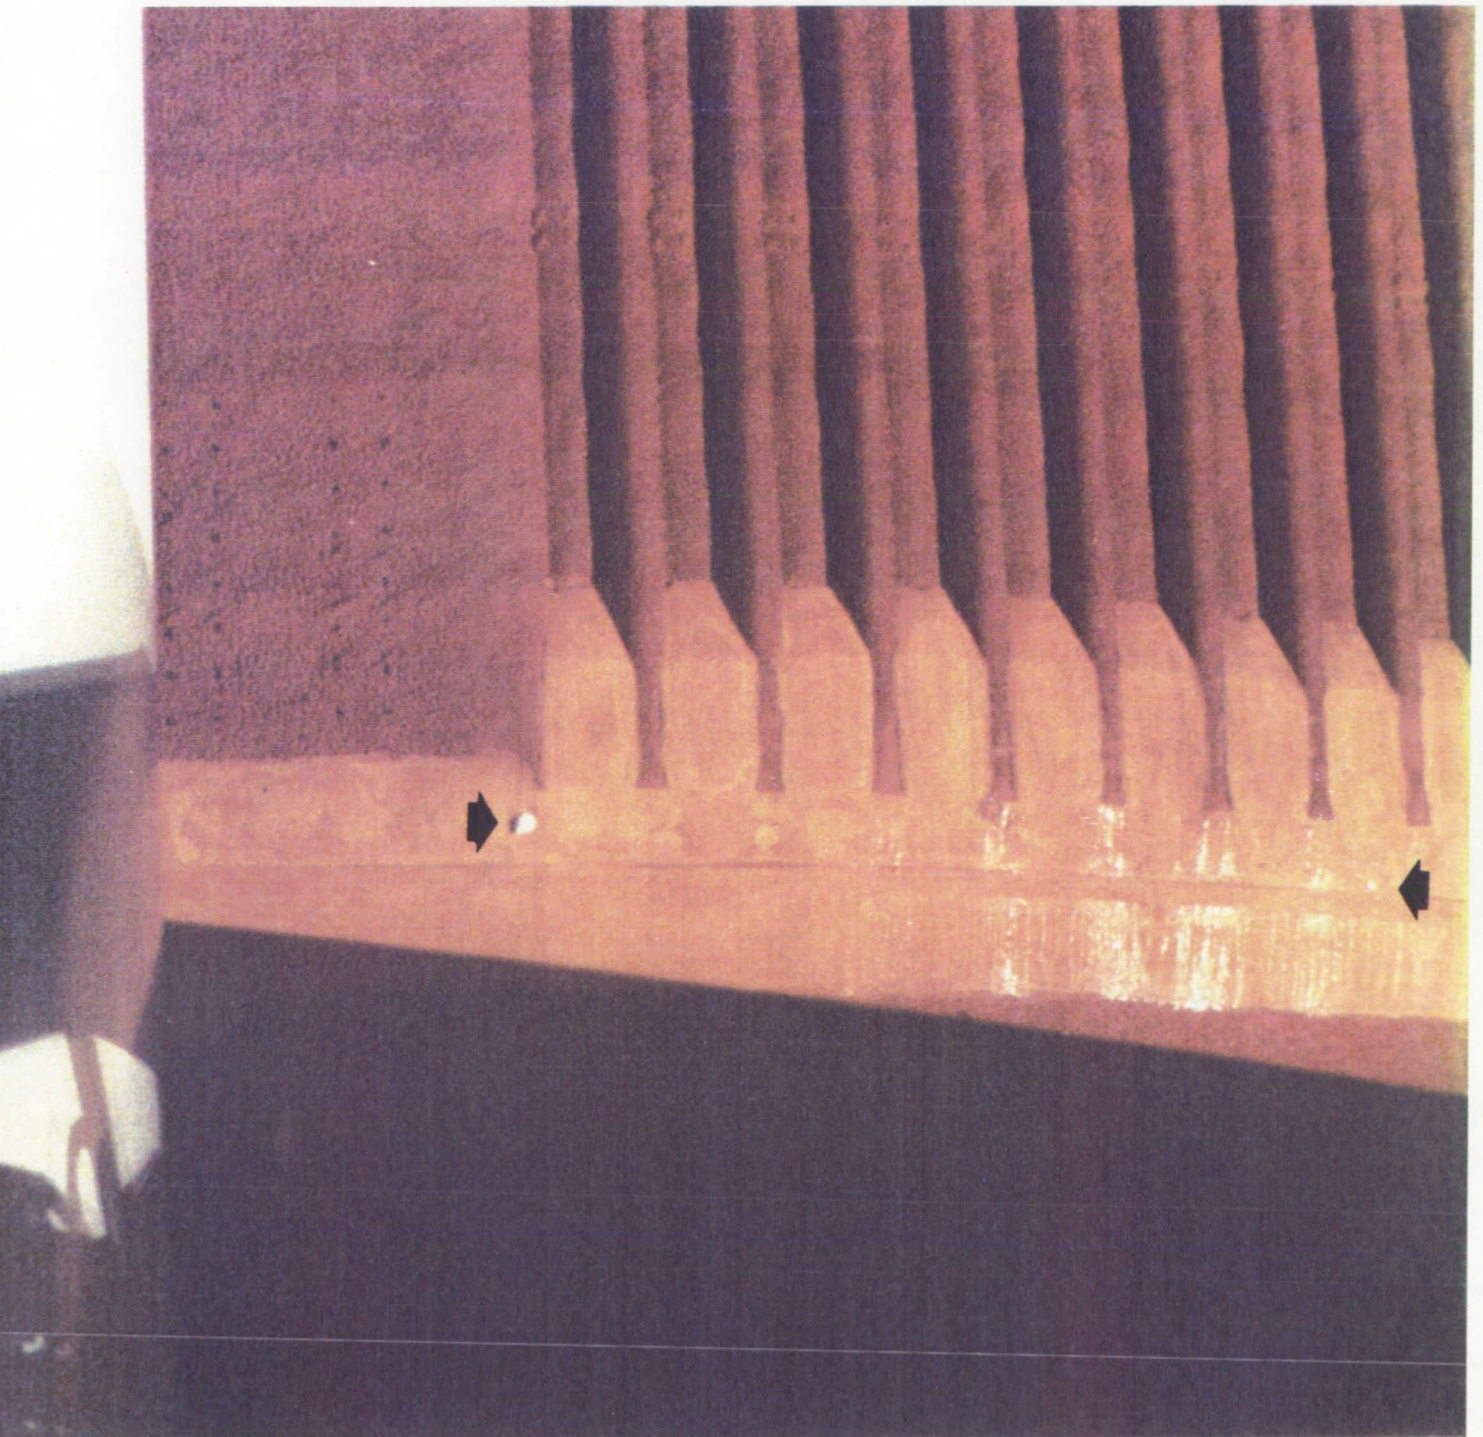
Ice/frost ball, 1-2 inches in diameter, formed on a small void in the LH2 tank-to-intertank flange TPS closeout. Some venting of vapor occurred while the ice/frost accumulated. Engineering evaluation determined this ice/frost condition was acceptable for launch. Two other frost spots also occurred on the flange closeout.

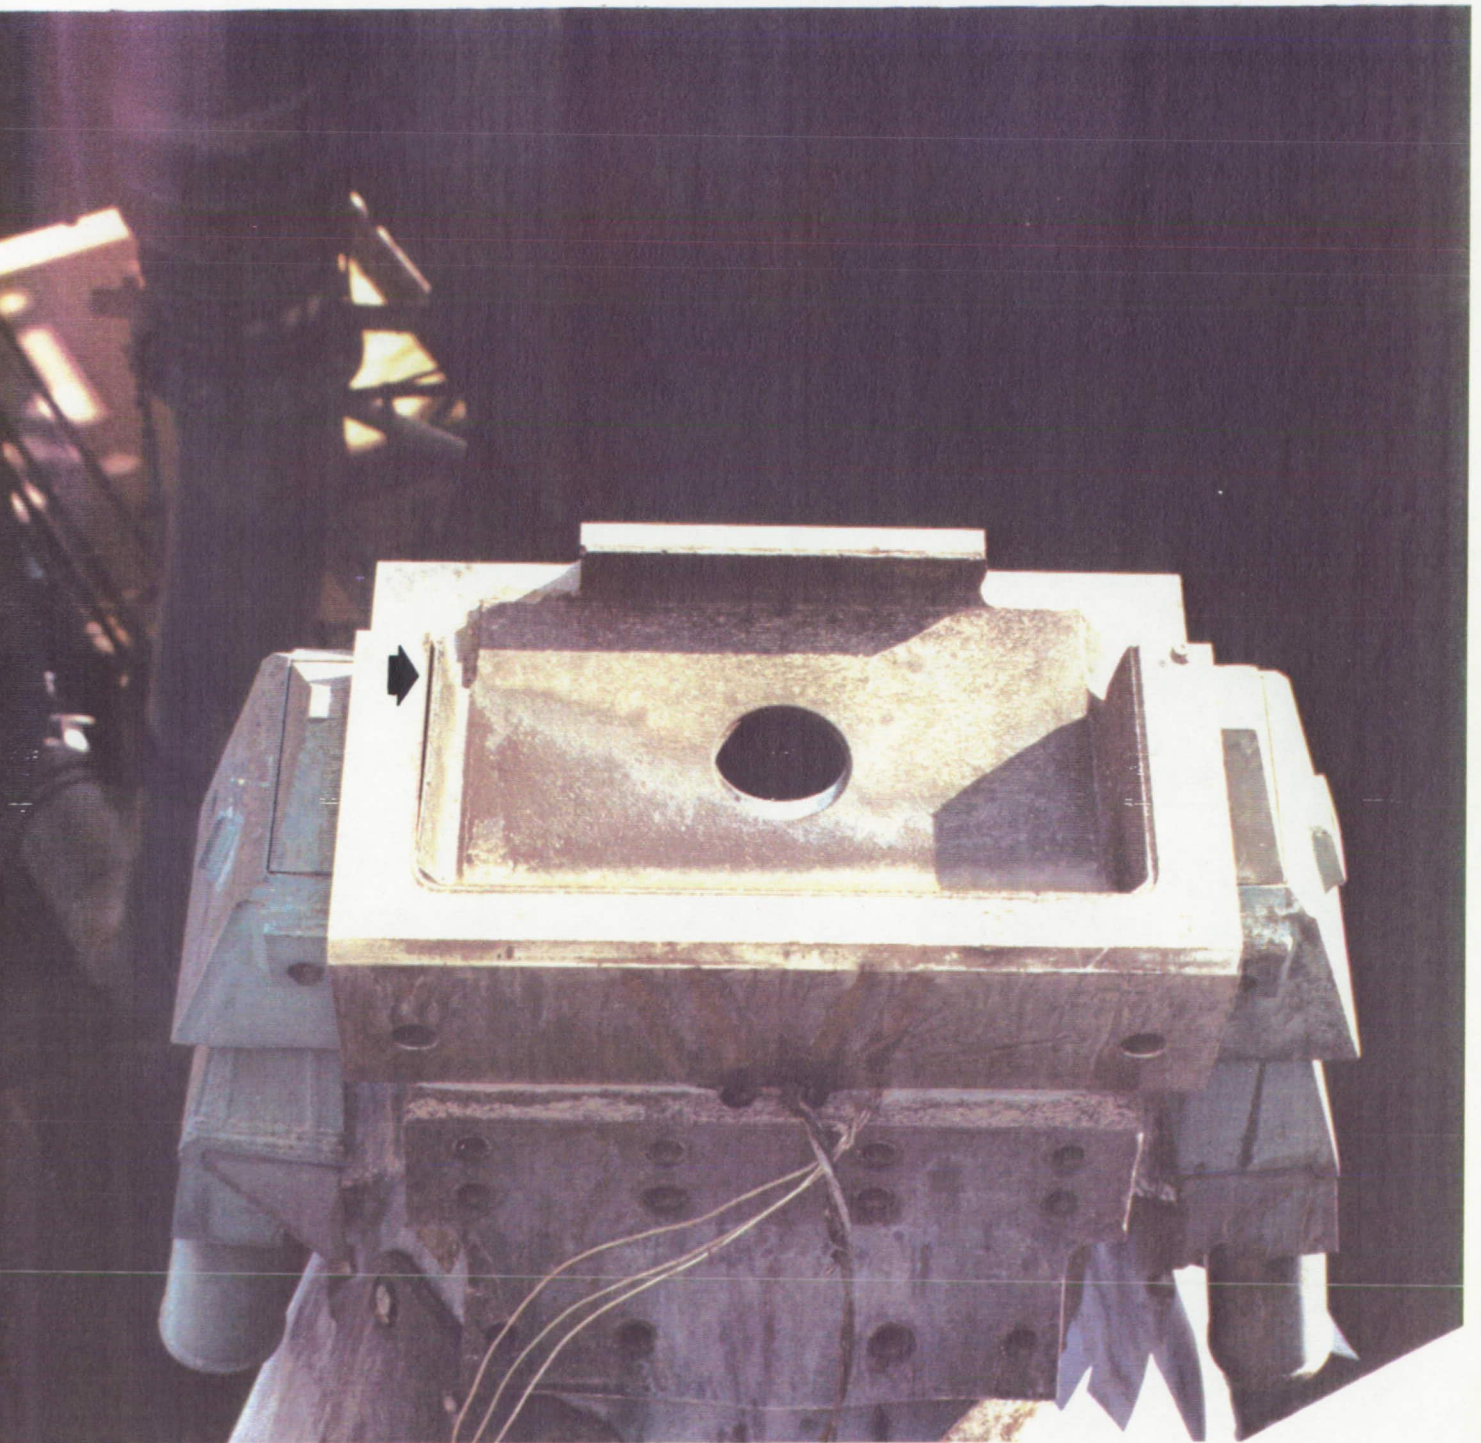
EPON shim material on the south holddown posts was intact but debonded along the sidewalls to various degrees

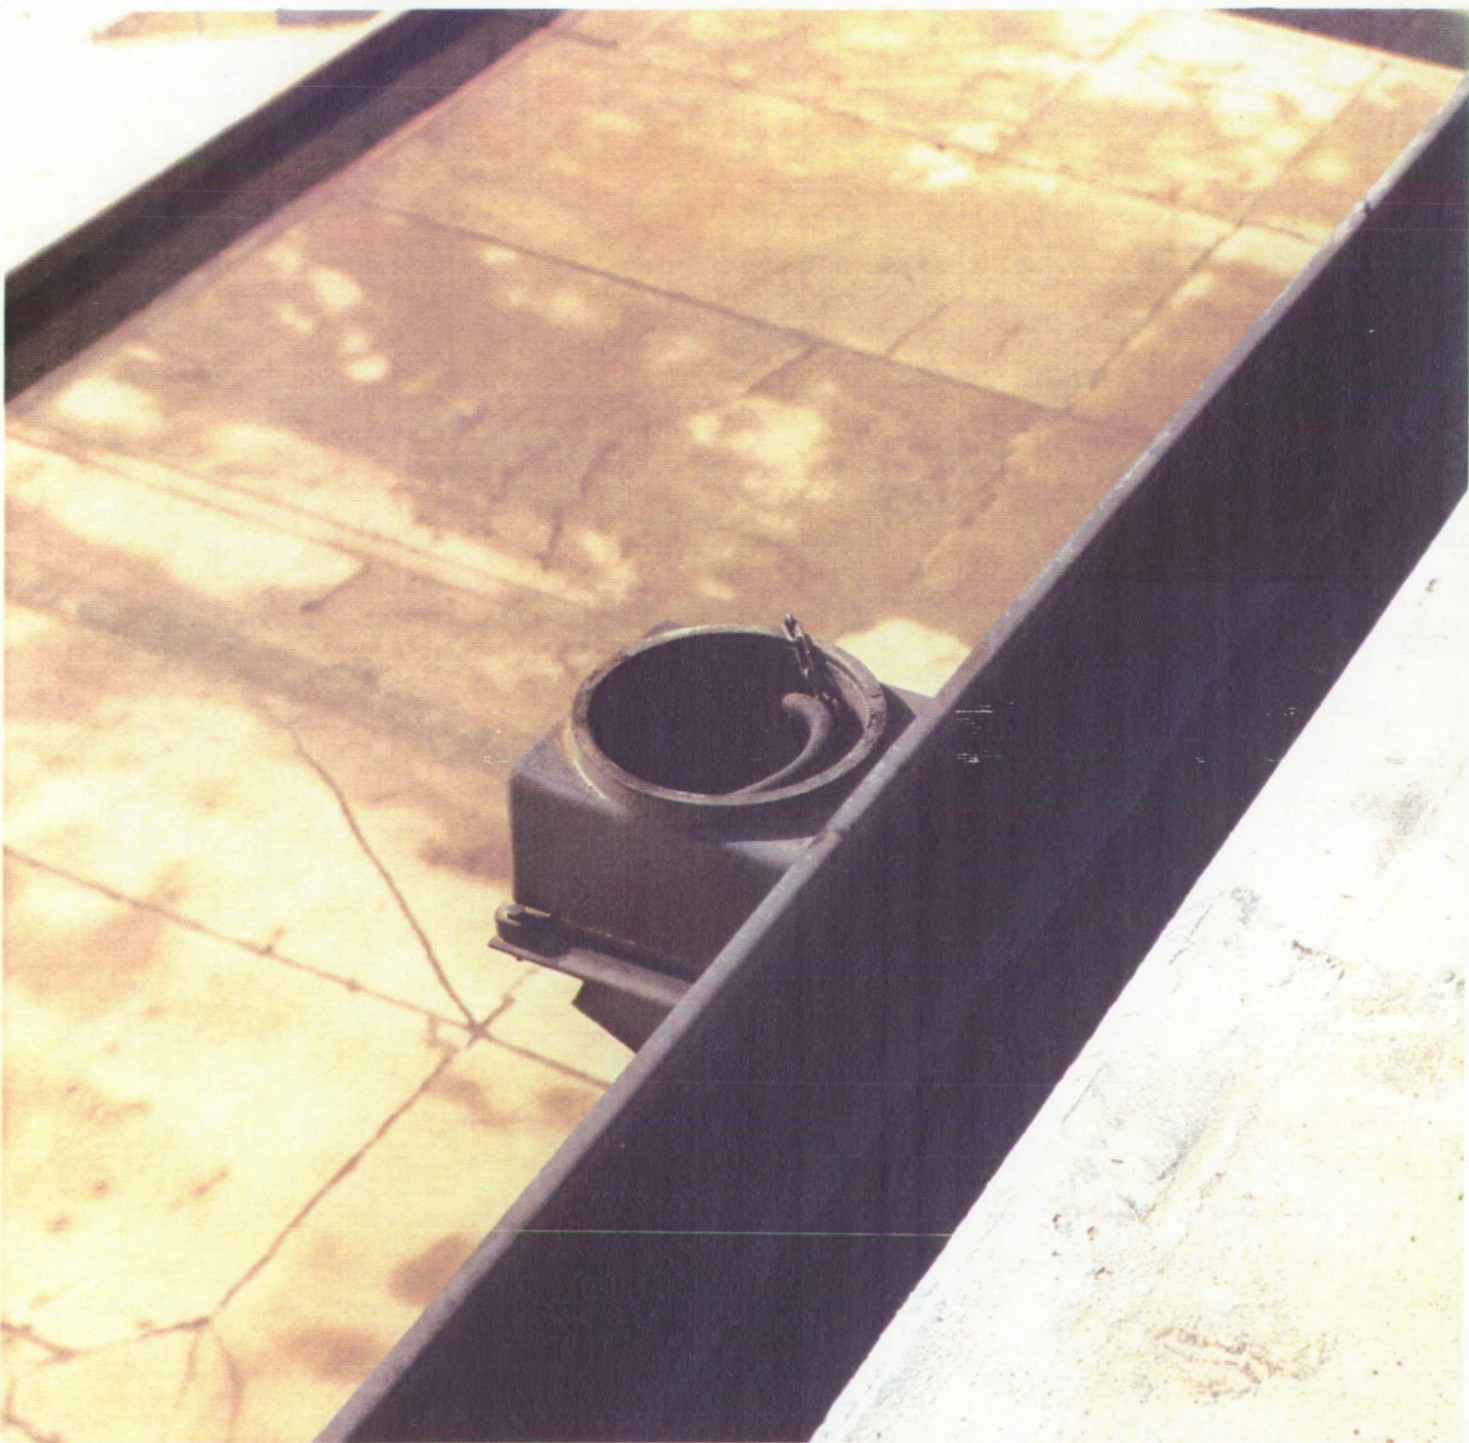
Electrical box cover was missing at southeast corner of MLP

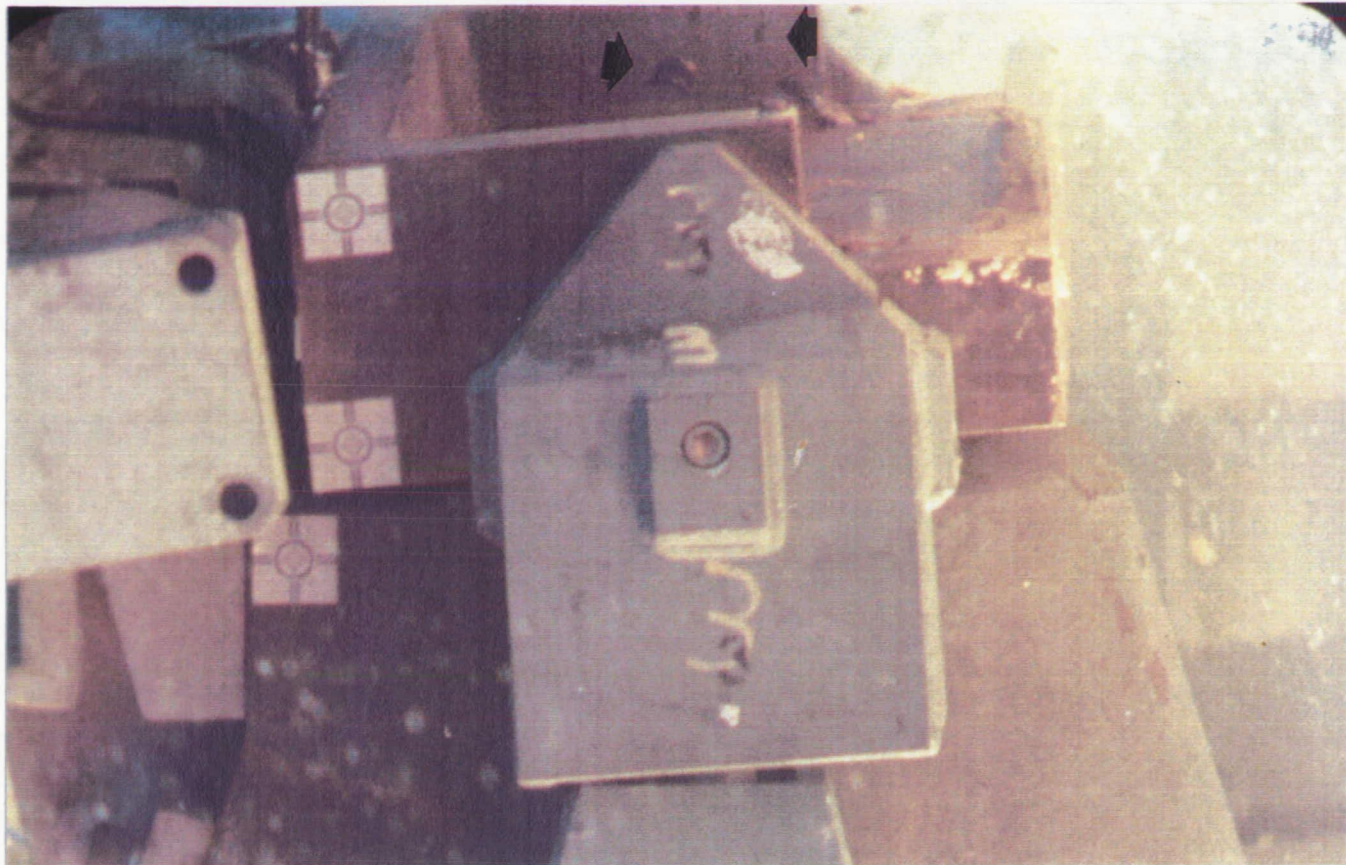
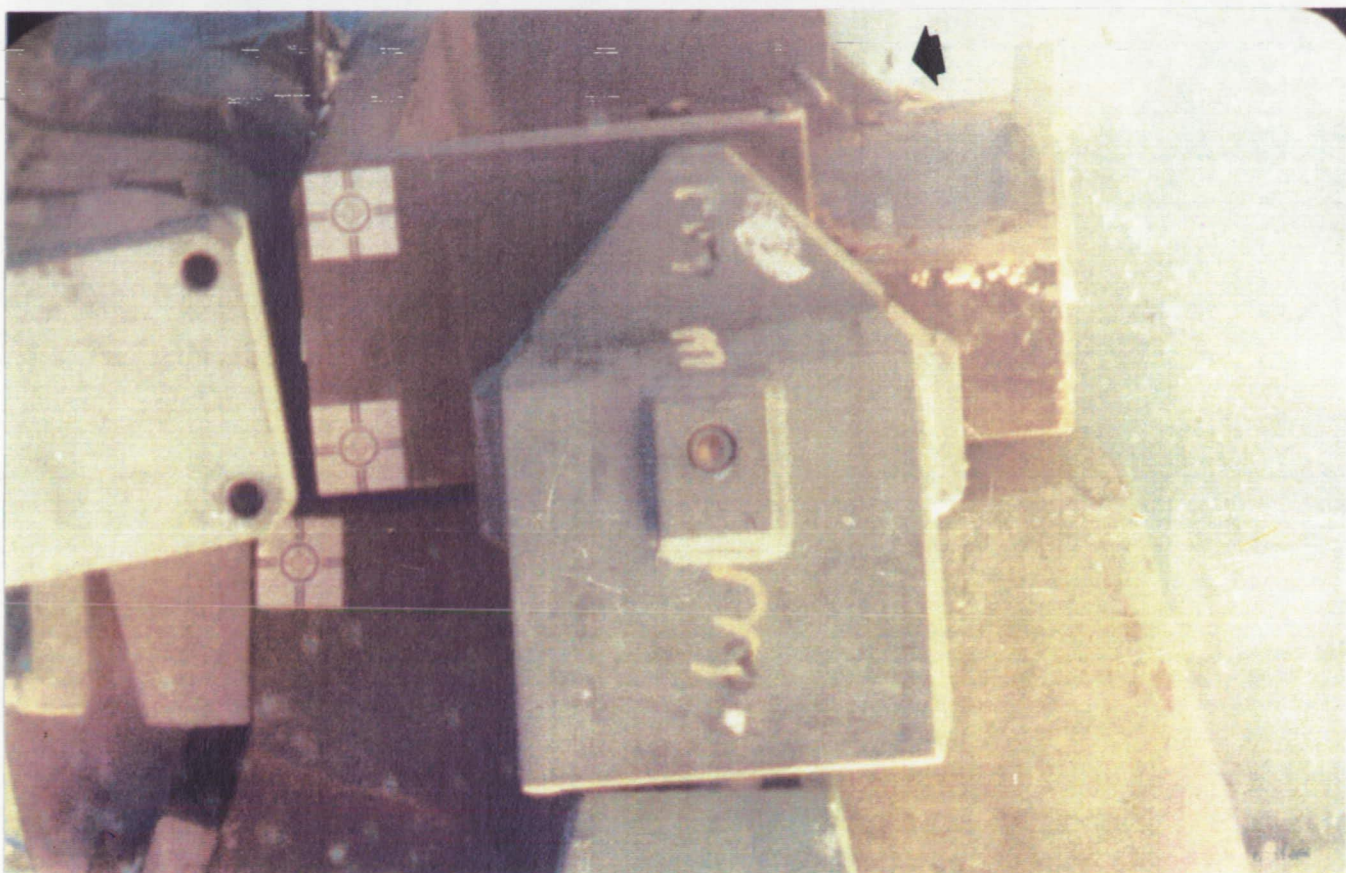
Five ordnance fragments, including the threaded part of an
NSI cartridge, fell from the HDP #7 DCS/stud hole

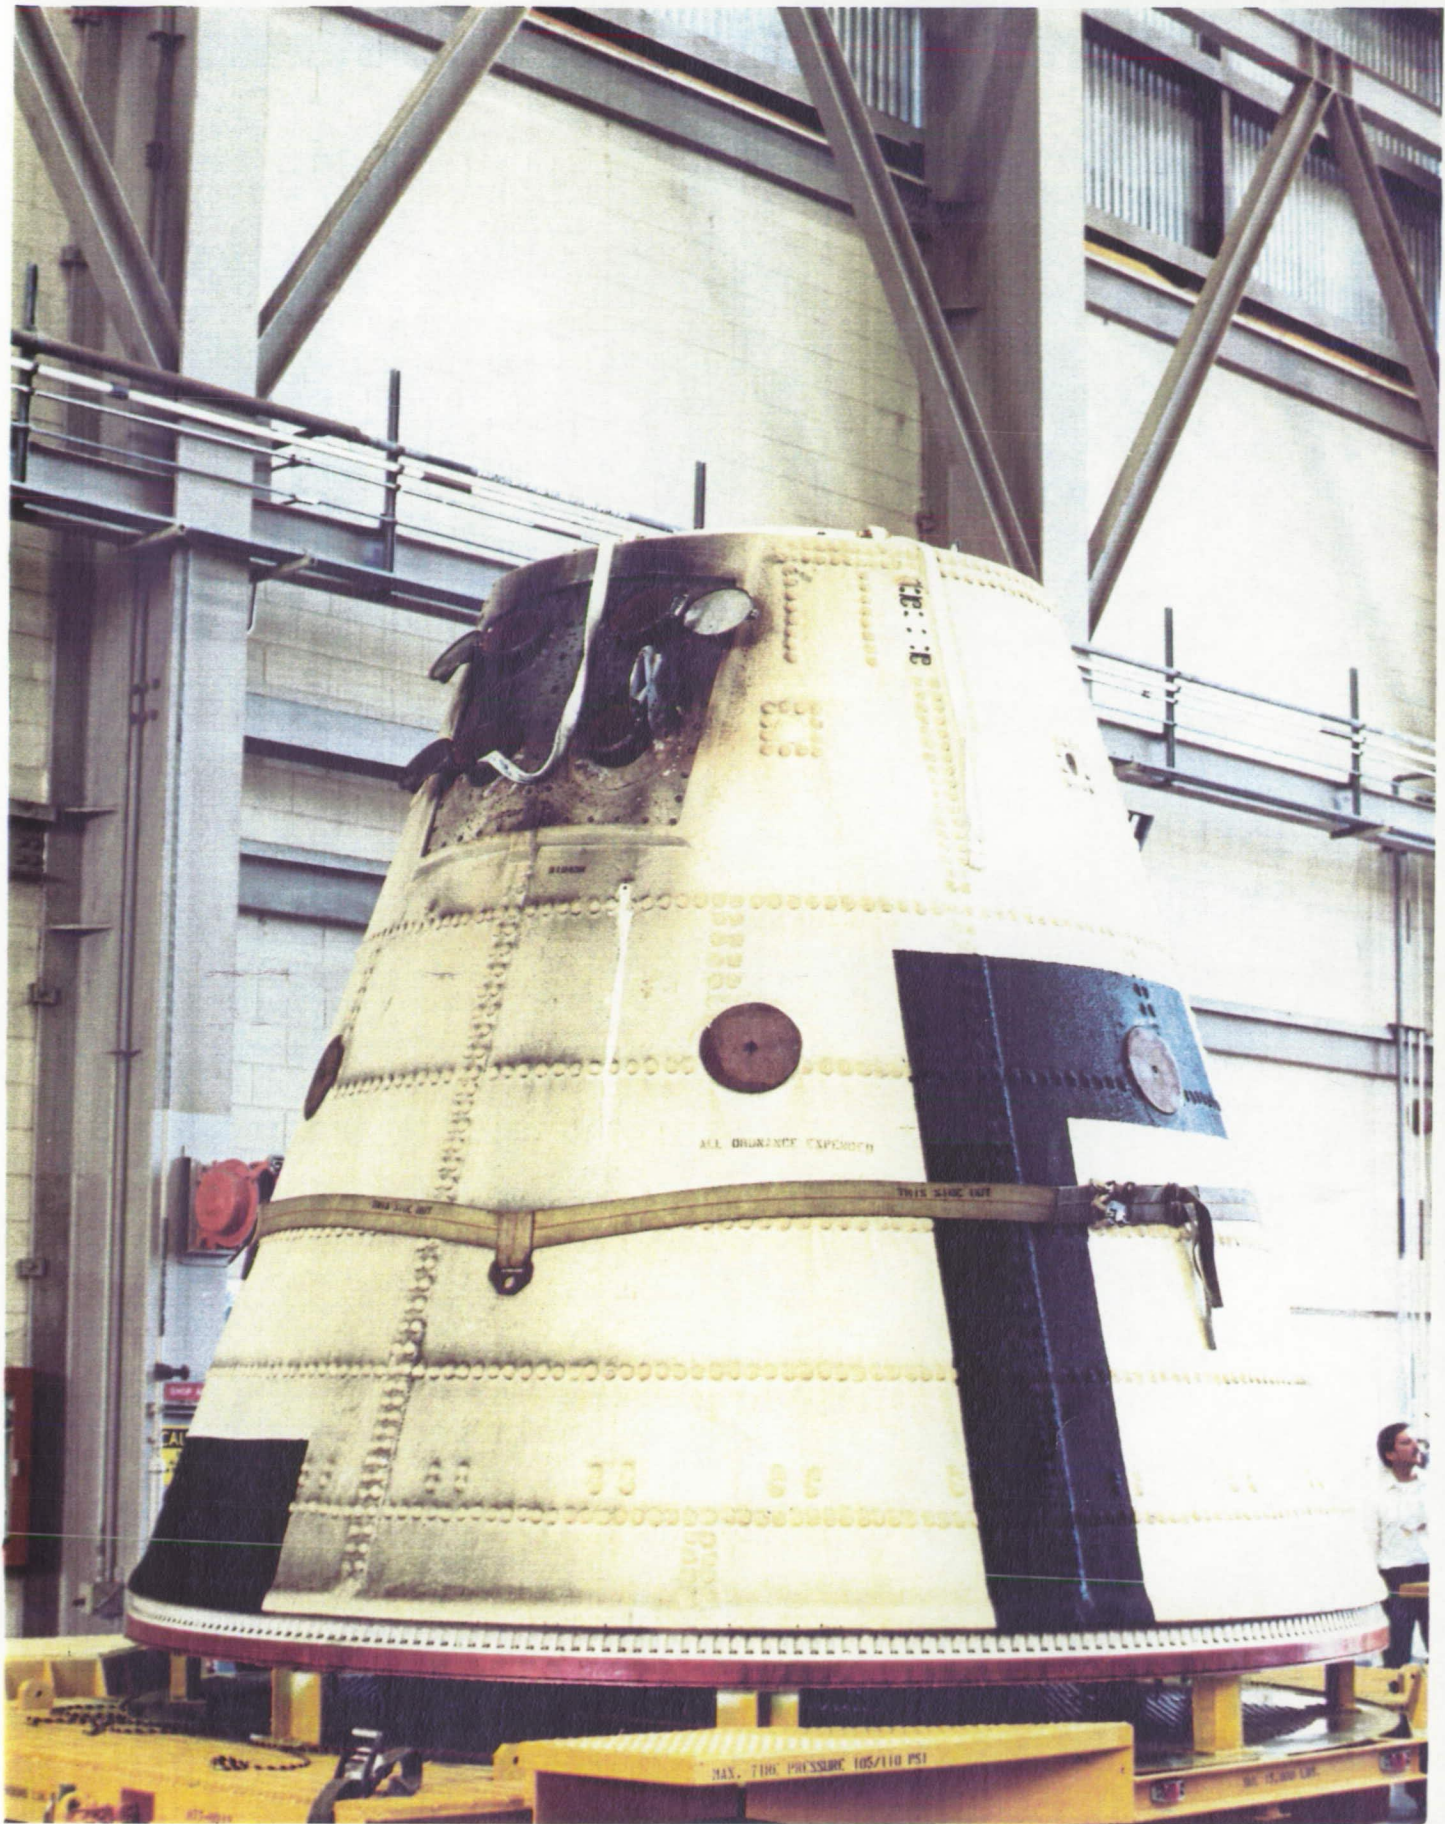
Post flight condition of the RH frustum. There were 52 MSA-2 debonds over fasteners, but no areas of missing TPS.

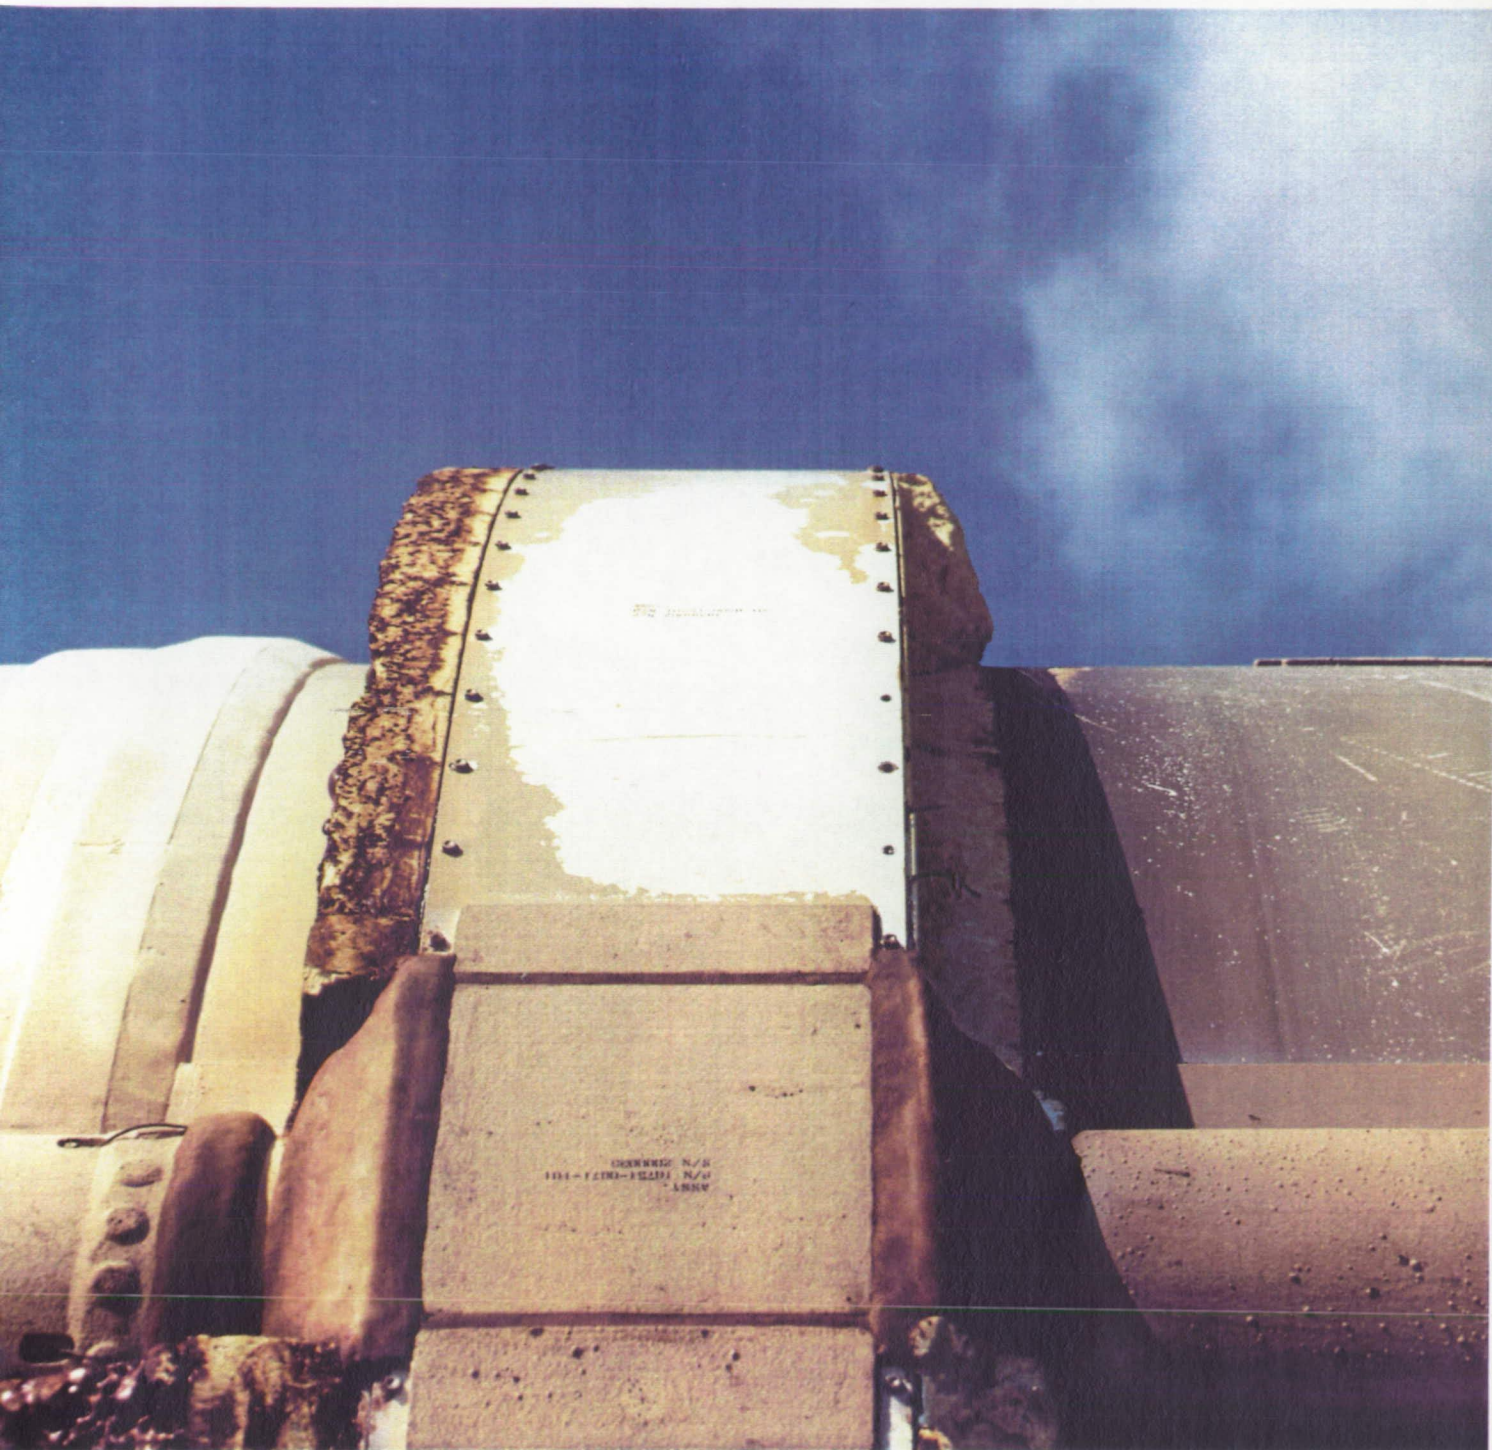
Three bolt heads were missing from ETA ring cover fasteners

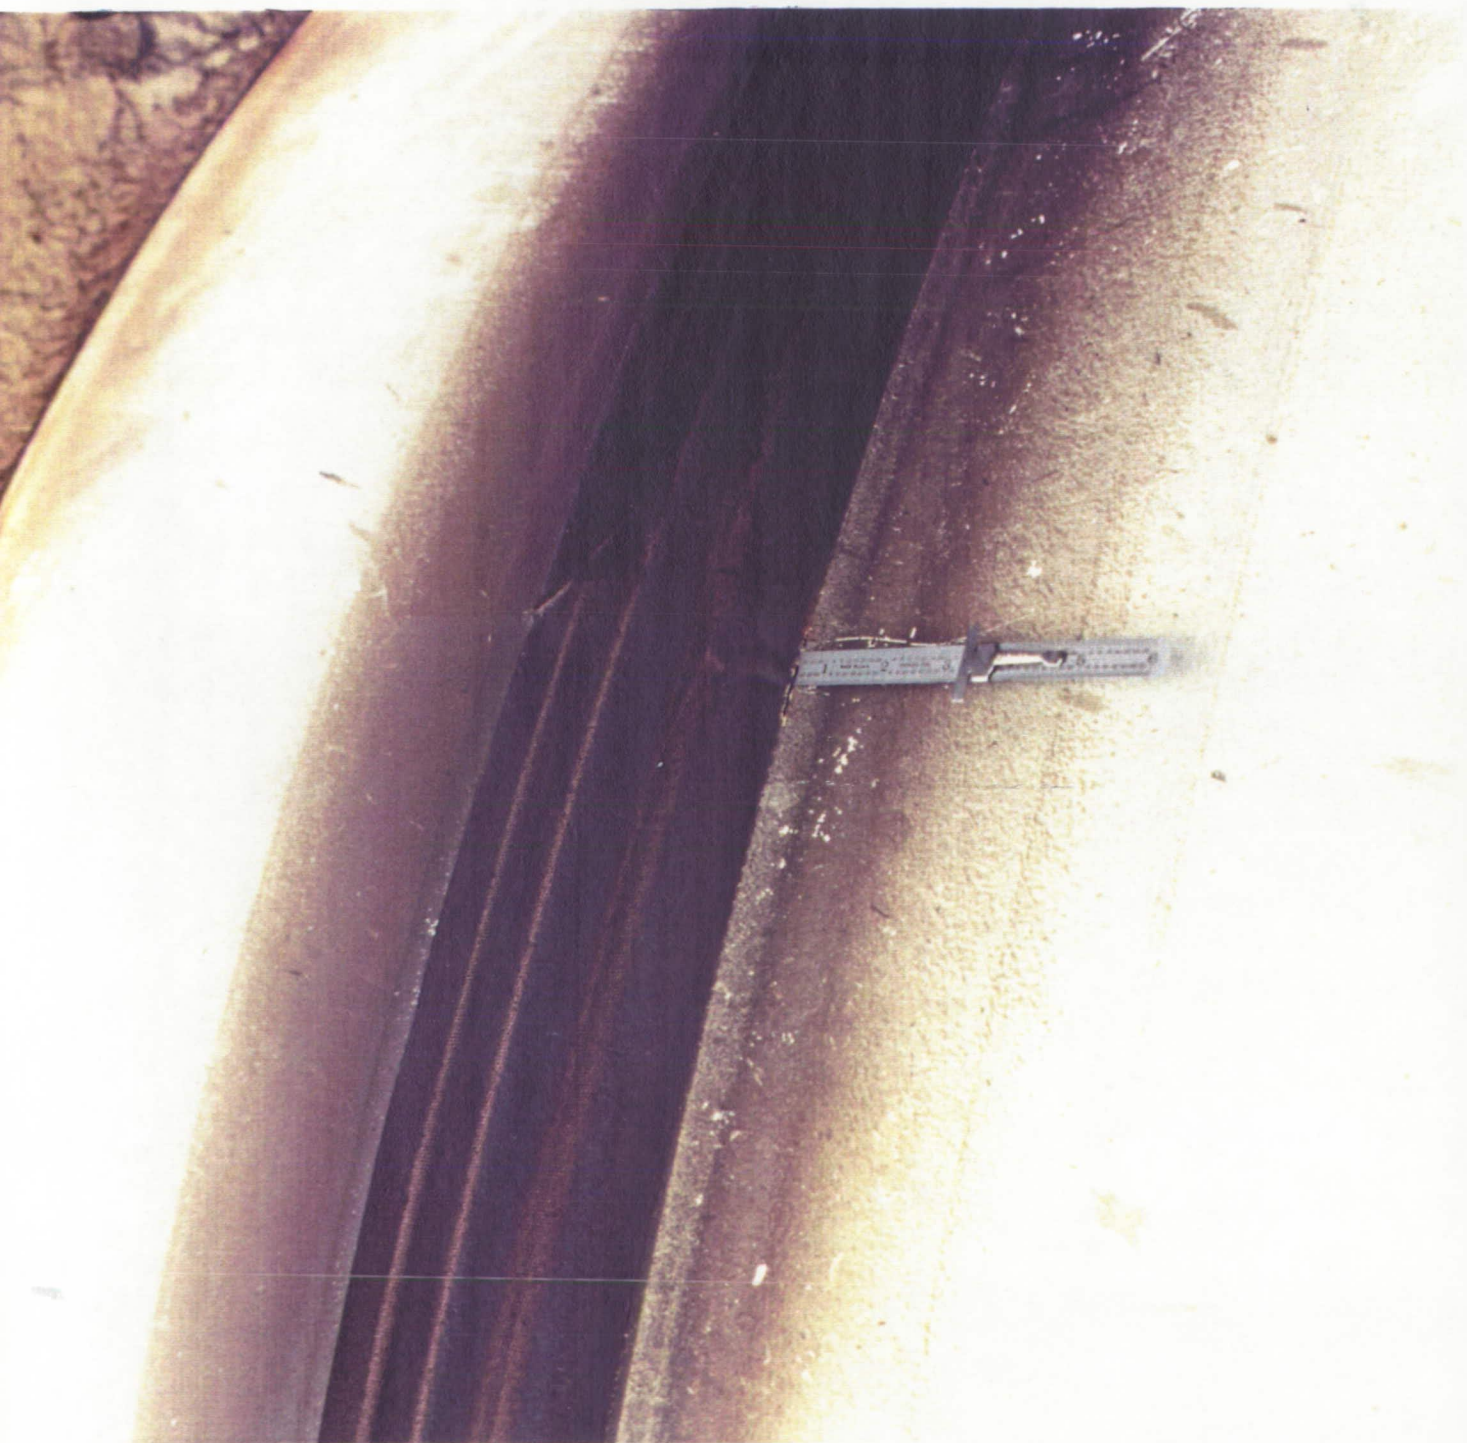
EPDM weather seals on the RH aft booster factory joint closeouts had 5 debonds, the largest of which measured 2"x0.25"
